**NASA CONTRACTOR
REPORT**

NASA CR-1829

THE HOT-SALT STRESS CORROSION CRACKING OF TITANIUM ALLOYS

by R. S. Ondrejcin

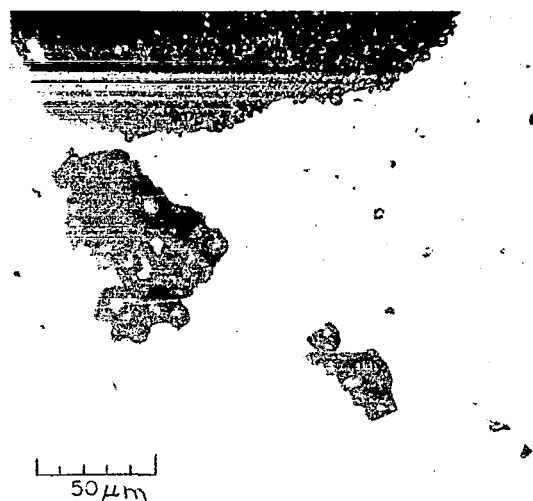
a. Salt Deposit at Room Temperature

b. Same as (a) After Reaching 650°F

c. Same as (b) After 80 Minutes

d. Same as (c) Enlarged

FIG. 4 HOT-STAGE MICROSCOPY OF NaCl CRACKING OF Ti-8Al-1Mo-1V AT 343°C

In hot stage microscopic tests at 343°C with Ti-8Al-1Mo-1V, NaCl corroded and stained the alloy after <10 minutes at that temperature, but cracking did not initiate until 75 to 90 minutes later.⁸ Minute corrosion stains at the salt crystals gradually enlarged forming a fairly continuous stain around the crystals, but cracks initiated before the stain became continuous. Corrosion products did not appear to spread outward from the salt-metal contact area (Figure 4). The alloy was corroded at salt-metal contact areas, and cracks nucleated only in these regions. (Figure 5). Cracking was not related to the size of the salt crystals because cracks also initiated at very small crystals.

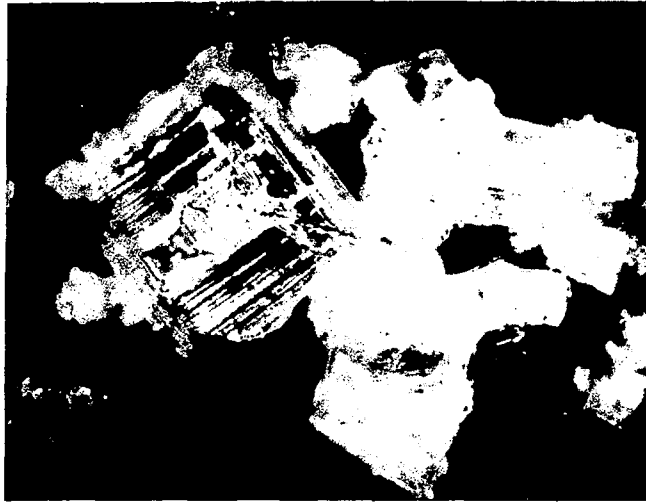
NaCl crystal on Ti-8Al-1Mo-1V surface (polarized light). Fluid inclusions appear as dark areas and lines parallel to crystal faces.

Corrosion pattern apparently related to a crystallographic feature of the salt crystal (250X).

FIG. 5 ASSOCIATION OF CORROSION PATTERN WITH FLUID INCLUSIONS IN SODIUM CHLORIDE

During corrosion of titanium alloys, water was shown to be present by mass spectrometry. The water probably came from the salt because NaCl crystallized from a saturated solution contains residual water that can be seen under polarized light as dark areas or lines generally parallel to crystal faces (Figure 5). Thus, some apparently dry crystals contain water and, therefore, can cause cracking.^{5,8}
